Review of the recent restoration of the Vefa Kilise Camii

Mine Esmer

Fatih Sultan Mehmet Vakıf University, Istanbul, Turkey.

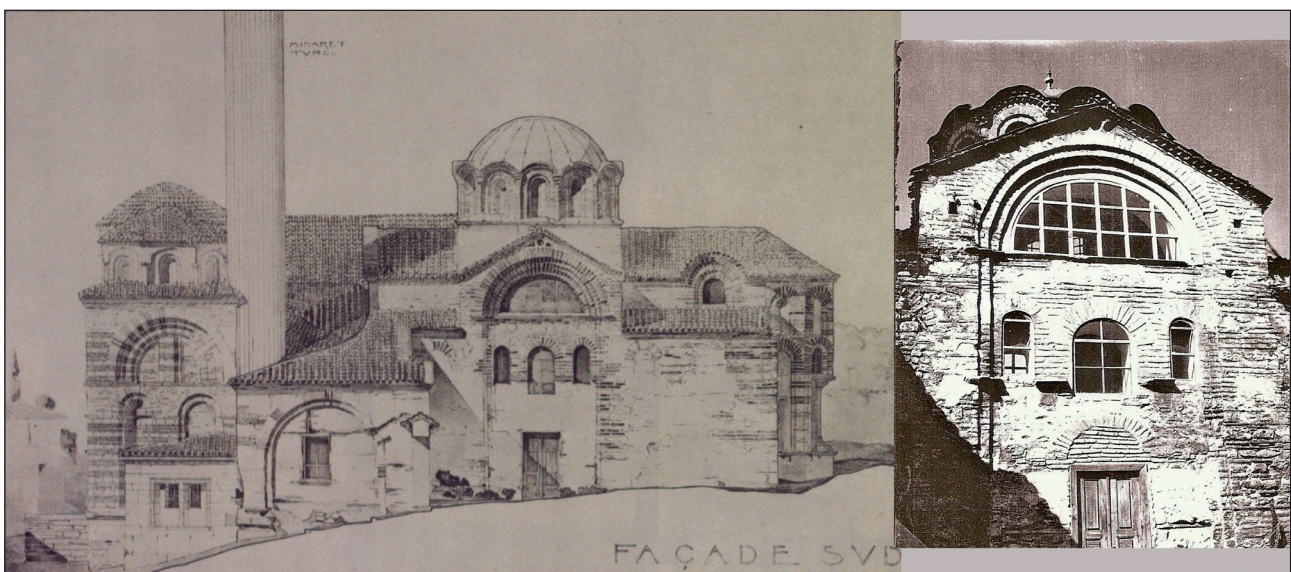
Figure 7. The traces of arches on the south facade (Ebersolt, 1913-Şengül Tümer, 1953)

There were also traces of arches on the south facade that can be seen in the drawings by Ebersolt, Van Millingen and also in the photographs by Şengül Tümer, an art history undergraduate student who completed her graduation thesis with Semavi Eyice in 1953. The traces were as well discussed in my PhD dissertation. During the 1972 repairs, these traces were lost. They have also not been investigated in the recent restoration, so the facade remained same as it was before the repairs regarding these two arches (Figure 7). Furthermore, the three partially visible bowls on the south facade have been cleaned and left open, but they are in need of protection. They have probably survived so long because they were plastered during the Ottoman period and are now exposed to the sun, snow, and rain (Figure 14).

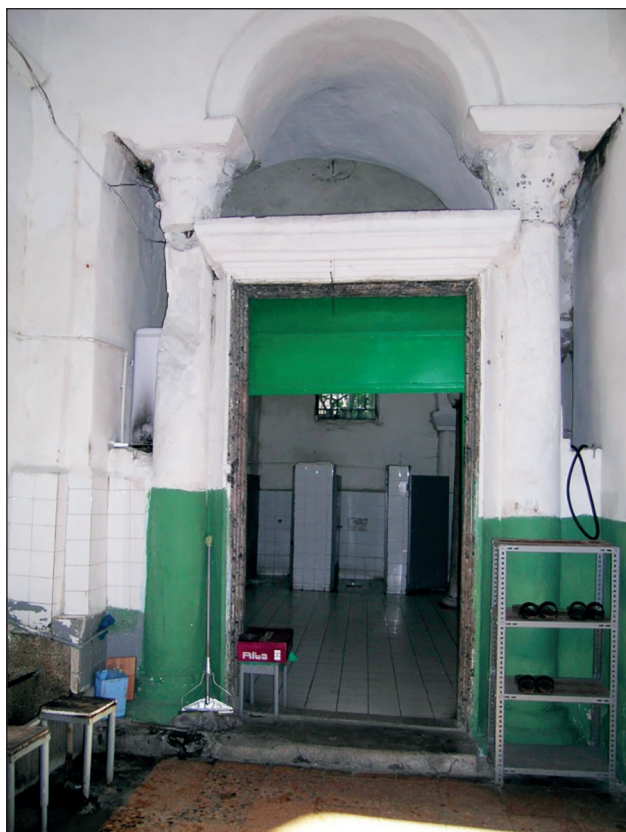
Figure 8. The condition of the north annex prior to restoration (2007).

In 1995, the north annex of the Vefa Kilise Camii were transformed into a wc unit. Aside from hygienic concerns, an improper plumbing intervention affected the historic structure. And ablution faucets were placed on the north wall of the outer narthex. Daily abuse by its users gradually deteriorated the structure. A shanty structure was added to the east of the south annex which was used with the south annex as a lodgement for the *mouezzin*. However the lodgement was rented to a family not related with the Kilise Camii. Moreover another shanty-unit with a metal structure was placed at the southwestern corner of the outer narthex and a person selected by the mosque congregation was dwelling in it. Also there was a room on the second floor of the north annex above the wc unit that the congregation used like a dormitory for some youngsters without a legal permission. Since In January 2009, the joinery on the eastern facade of the building was replaced with PVC windows. Istanbul Regional Directorate of Foundations became aware of the situation, but did not initiate an action. Furthermore, during the repair work, it was discovered that cement mortar had been carelessly applied to the parapet slabs on the balcony of the minaret. As well for this, punishment should be meted out to whoever was responsible.

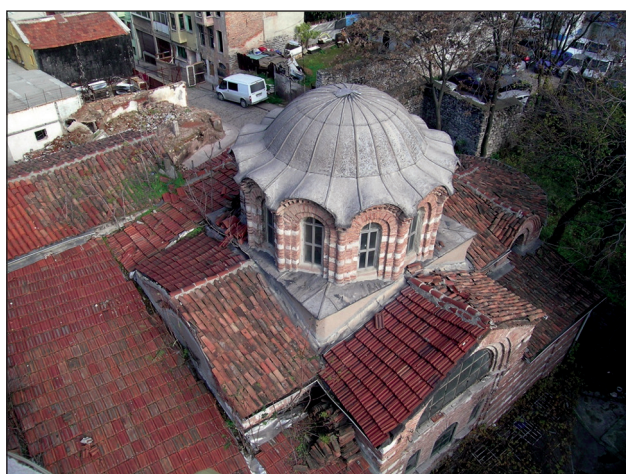
Figure 9. The condition of the roof prior to restoration (2007).

Rain and snow were leaking in through the building's roof and facades, causing damage to the walls and ceilings (Figure 9). Cement-based mortar used to repair the building in 1955, 1965, 1972, and 1987 consecutively contained salts that leached into the brickwork, causing efflorescence. It would therefore not be incorrect to say that the structure was in dire need of urgent repair prior to 2018 in order to stop its relentless deterioration.

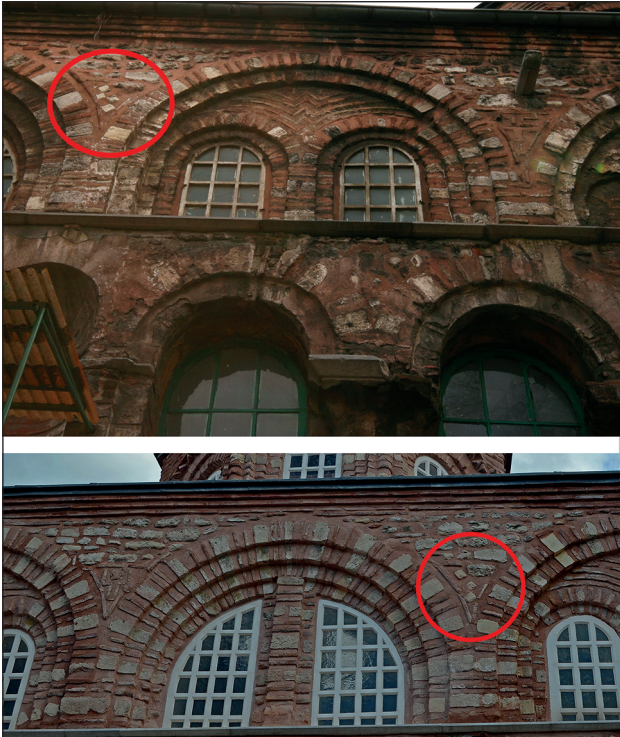
The following issues, however, might have benefited from better interventions: pointing and investigating traces in specific areas, deciding what color to paint the walls and ceilings, and some of the new fabrications. It was worth paying attention to the special decorations on the facades. Among them is the checkerstone motif between the two arches over the entrance door on the outer narthex's western facade (Figure 12). The checkerstone motif was not appropriately pointed. Even in the previous dilapidated state of the facade, the motif looked more discernable. A second motif is the meander motif on the northern facade, which Lioba Thies discovered and that I stressed in my dissertation as a point to be careful with during repair work. This part of the wall was simply pointed without investigating the motif (Figure 13). And the meander motif is probably lost irreversibly.

Figure 12. The checkerstone motif (Above: 2007 - Below: 2021).

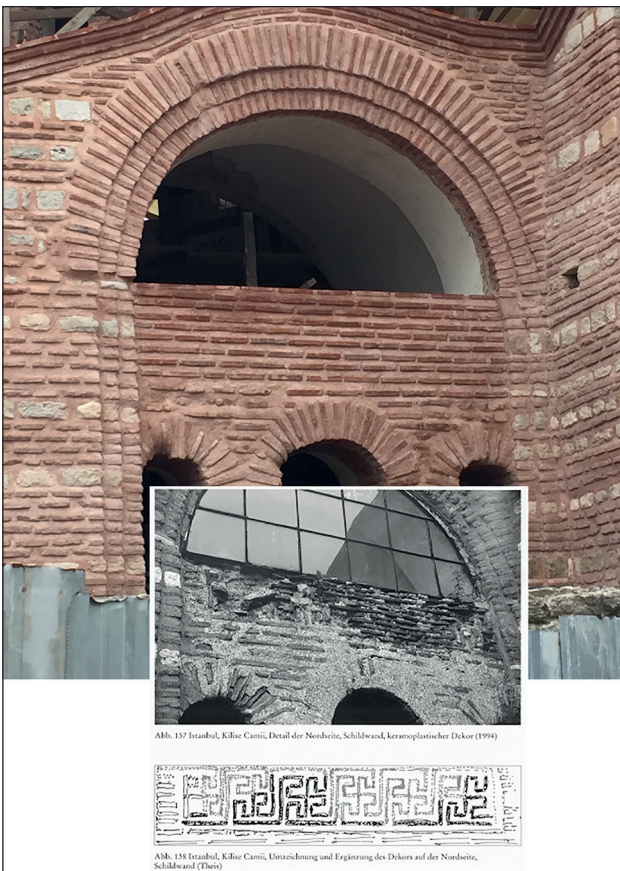
Figure 13. The place of the meander motif (Esmer, 2019 during repair- Theis, 2005)

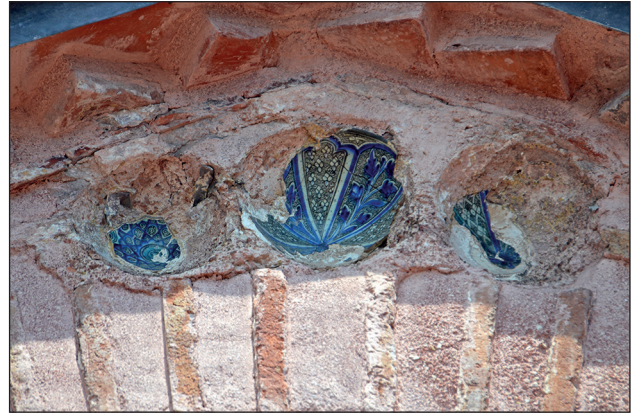
Figure 14. The bowls left open after the repair (Hendrix D. 2021)

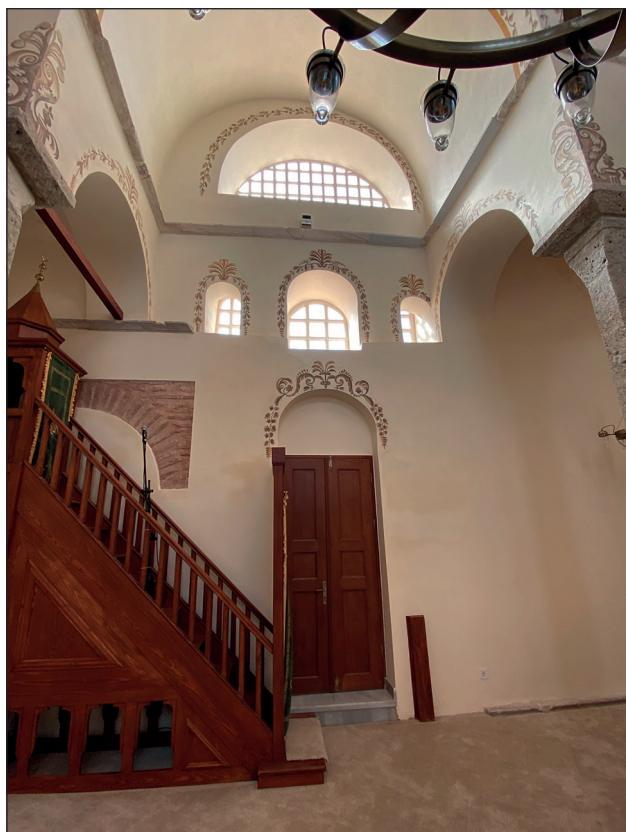
For interior a yellow color was preferred at the last repair, likely due to rasping during restoration and the discovery of old layers. However, this yellow color is very dominant and does not look convenient. A softer tone would have been more appropriate. The Ottoman decoration from its last repair is forced into any surface that is available (Figure 15). There are even instances where hand drawn decorations have been applied to asymmetric surfaces, which makes them look odd. The windows made of white portland cement on the upper elevations would look better if these were placed a little inside and had a shadow share (Figure 16). The entrance portal, especially the tone of the wood veneer could have been much better chosen (Figure 17).

Figure 15. The interior color and hand drawn motifs (2021)

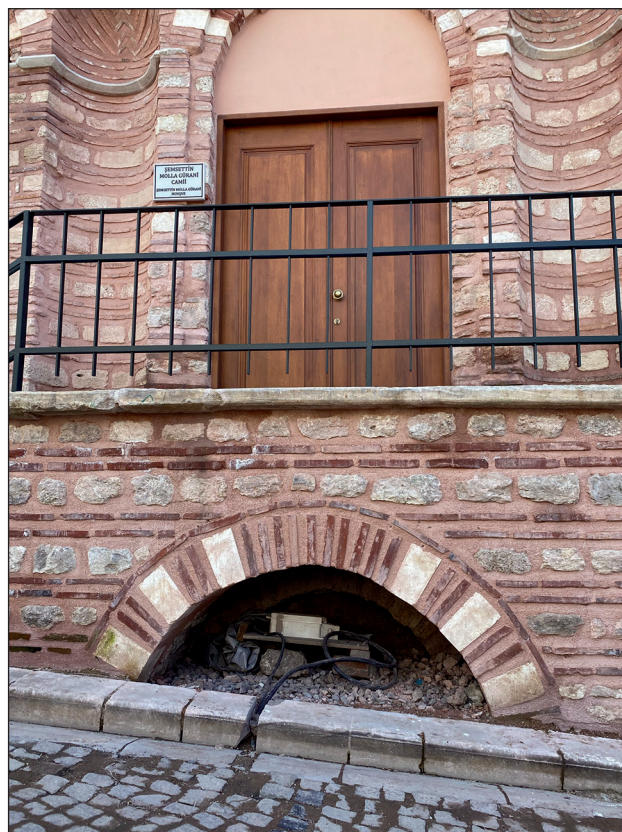
Figure 17. The entrance portal (2021)

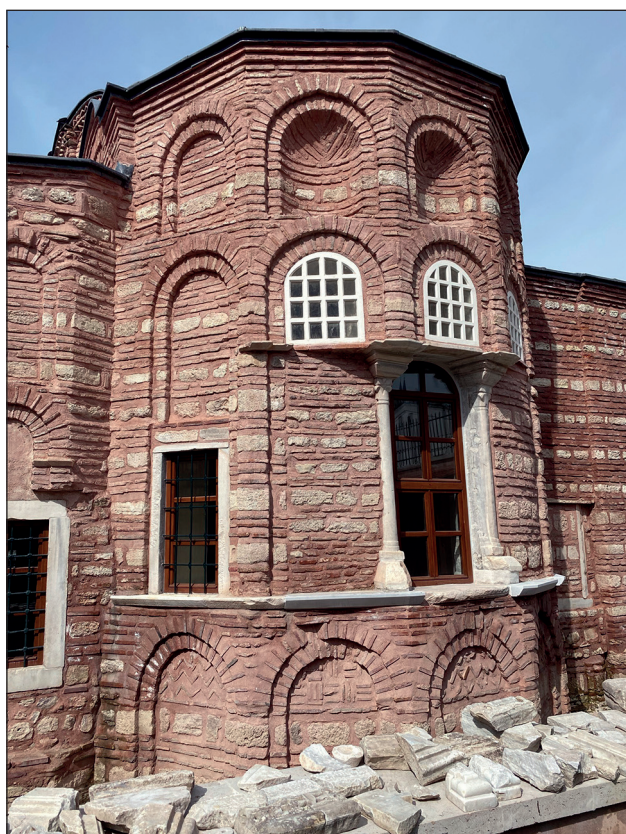
Figure 16. The windows from white portland cement (2021)

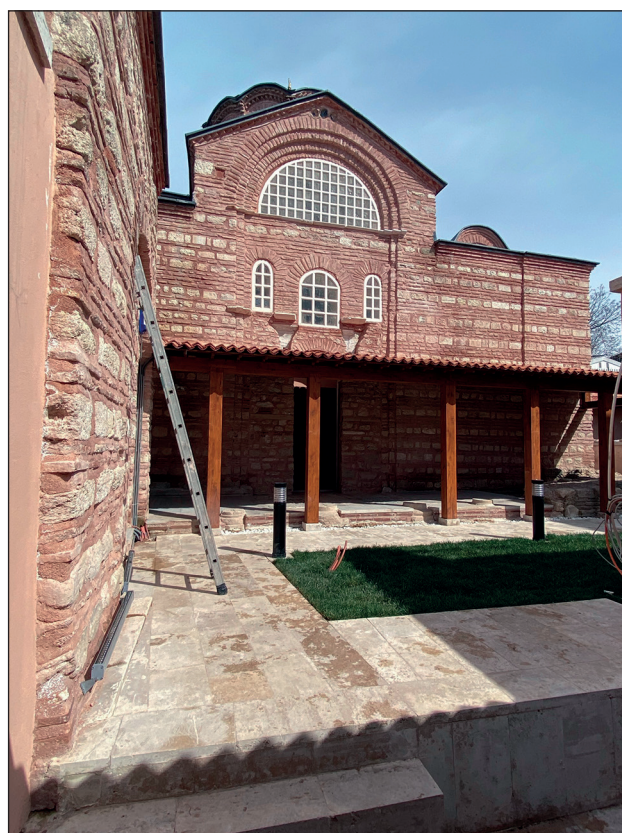
Figure 18. The wooden porch (2021)

One of the most problematic applications is a wooden porch next to the south facade and blocking the triple opening completely (Figure 18). Wooden posts with wide cross-sections were used frequently, as if they were meant to support a 3-storey building, when they only needed to support a wooden porch.

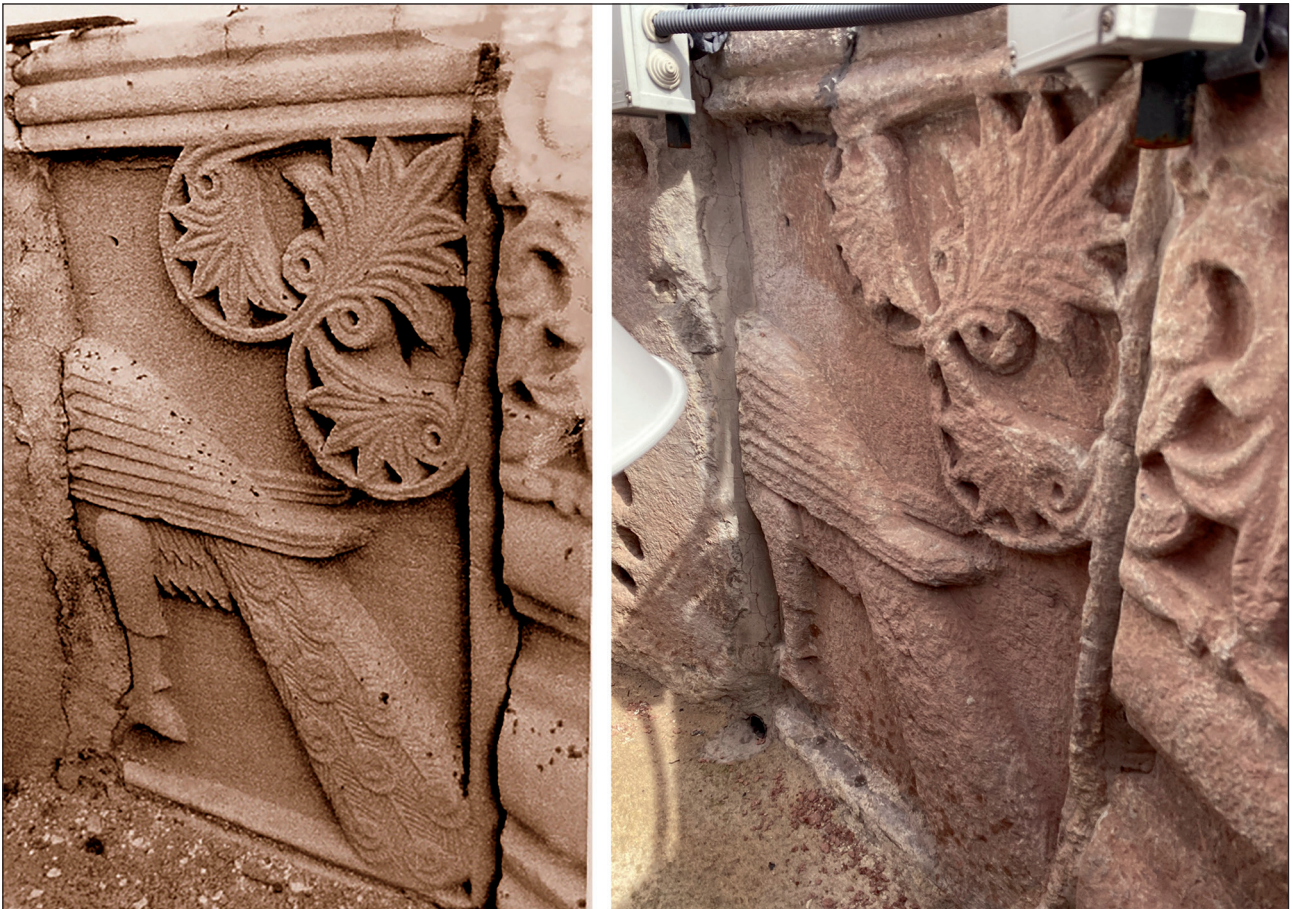
During the restoration the parapet slabs of the minaret were cleaned off the cement coating but, while the majestic peacock-adorned slab and other slabs remain in-situ, the color of their stones faded and some details were obliterated while cleaning the cement on them, which is unfortunate (Figure 19). Moreover, currently the interior of the parapet of the minaret is cluttered with wires and speakers, causing it to look unkempt.

Figure 19. The figures on the parapet slabs of the minaret balcony (Erdoğan, 1996 - Esmer, 2021).

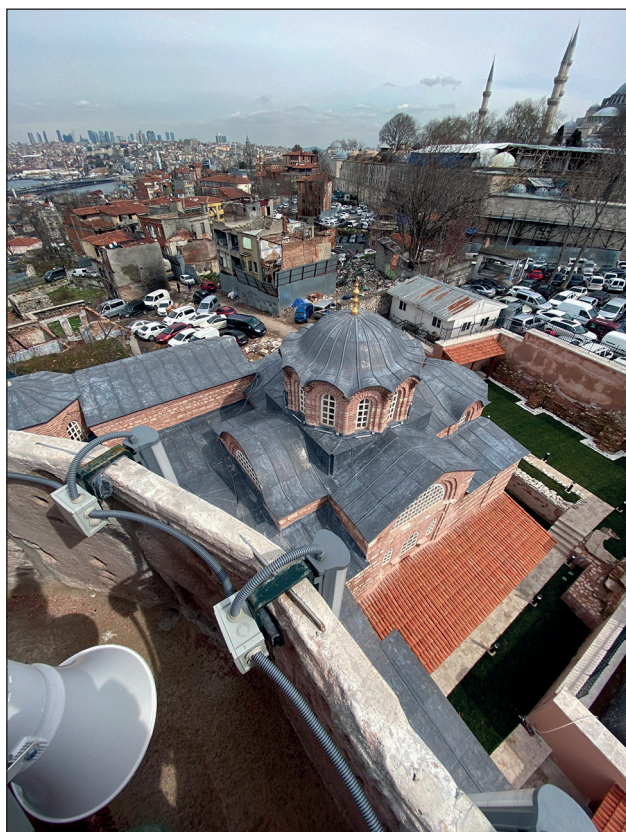
Finally it is important to make a few remarks on the nearby surroundings of the monument which is located in Süleymaniye World Heritage Site. The surrounding areas of the Kilise Camii look more like a post-conflict zone, rather than a UNESCO World Heritage Site in the photograph taken from its minaret balcony (Figure 20). There is a parking area for motor vehicles on every plot of any demolished structure. In such an environment it is not possible to expect that the Vefa Kilise Camii will be maintained, clean, and its preservation will be safeguarded. Further, it is located in a renewal zone that is capable of producing major changes in quantity within a short amount of time. Based on

these circumstances, Kilise Camii is continuously threatened by its environment, and is at risk.

Figure 20. The nearby surroundings of the Vefa Kilise Camii (2021)

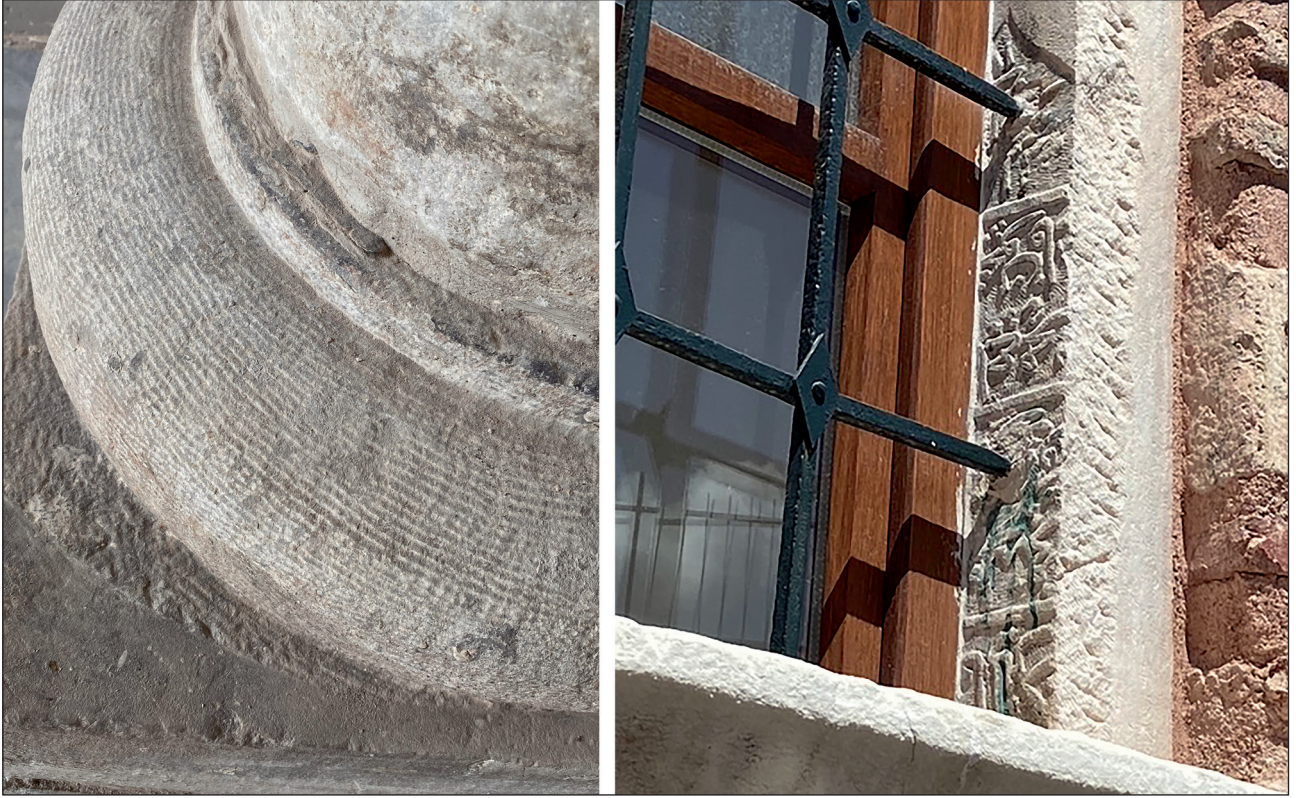
Interventions should ensure safety and durability while preserving heritage values as much as possible. Within each small corner of the monument one can detect an important detail of its long past, building/repair technology, approach of the period and so on. For instance after the cleaning of the paint layers one can see the masons's toolmarks on one of the delicately carved column bases at Vefa Kilise Camii or a spoiled Ottoman slab used as a lintel at one of the openings on the main apsis on the eastern facade (Figure 21).

Figure 21. The toolmarks on the column base and an spoliated Ottoman slab (2021).
