Kiliçlar train station in state railway history and current preservation problems

Abstract

This study examines the architectural characteristics, historical context, and current conservation challenges of Kılıçlar Station, constructed in 1925 as part of the Ankara-Sivas railway line during the early Republican era in Turkey. The station follows the standardized Type III typology commonly applied to rural railway buildings in the late Ottoman and early Republican periods. Originally serving a military and logistical function, the station is composed of a two-storey central mass with single-storey wings, built with masonry, wooden elements, and Jack Arch flooring. Over time, the structure has experienced material deterioration, primarily due to moisture damage and inappropriate alterations. Through on-site documentation and typological analysis, this study evaluates the building's current condition and proposes restoration interventions based on principles of minimal intervention, material compatibility, and reversibility. The findings underline the importance of preserving Kılıçlar Station not only as an architectural asset but also as a significant representation of Turkey's earl

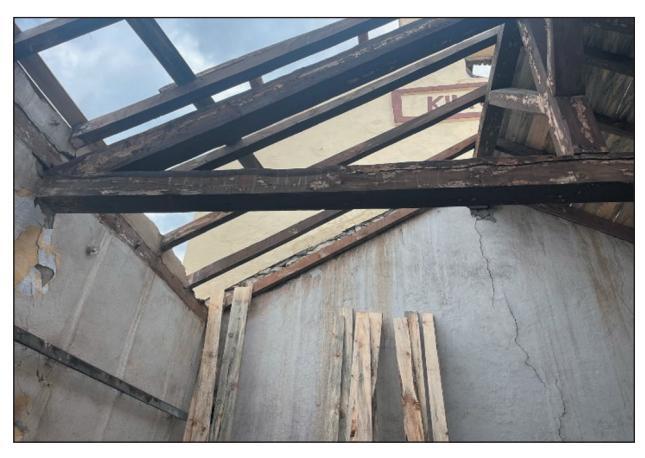
Figure 8. Condition of the roof before simple repair

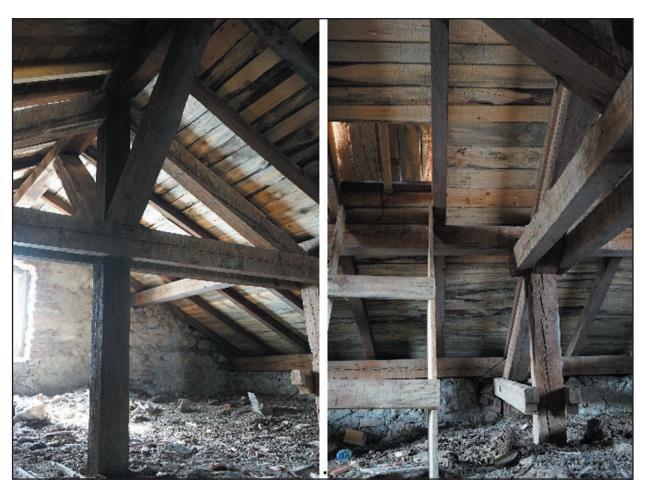
Figure 9. Building roof after simple repair

The roof, which had been in a dilapidated state, was recently repaired. This intervention included replacing many of the purlins, rafters, cladding boards, and tiles. Of the two original loading bay doors, one remains intact, while the other has been dismantled. However, its metal components and original wooden fragments have been preserved and may be reused in future restoration work. Over time, alterations to the door and window placements have been made to accommodate changing functional needs.

Original wooden elements such as door and window joinery, ceilings, floors, and stair railings will be examined. Intact components will be retained, while deteriorated elements will be renewed using historically accurate wooden materials. Although the roof was recently repaired, its structural integrity and workmanship will be reassessed and reinforced if necessary.

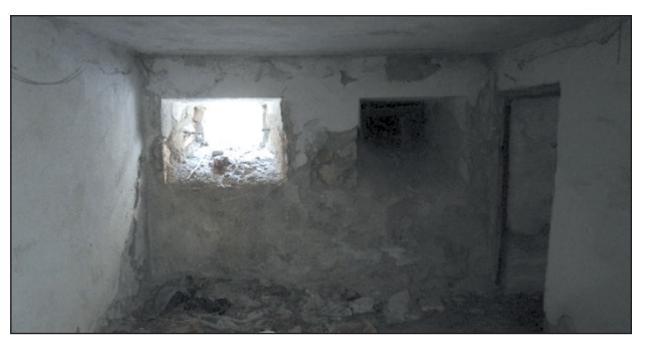
Figure 13. Basement floor areaway windows

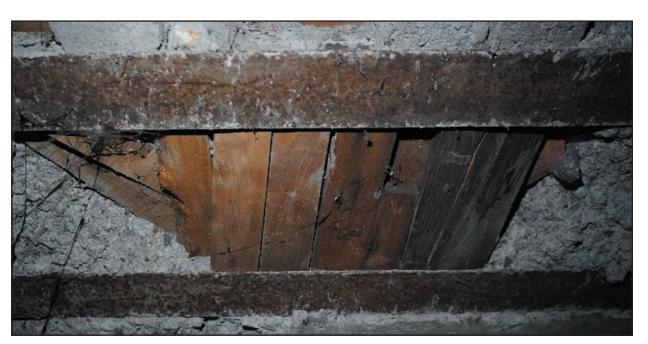
Figure 14. Metal elements of the jack arch flooring

The flooring system between the ground and basement levels includes iron jack arches currently concealed beneath cement plaster. This plaster will be removed to assess the condition of the iron elements. Rusted or structurally compromised members will be replaced with replicas made to match the original specifications. Elsewhere, wooden floor beams will be inspected, and any decayed sections will be replaced with equivalent materials.

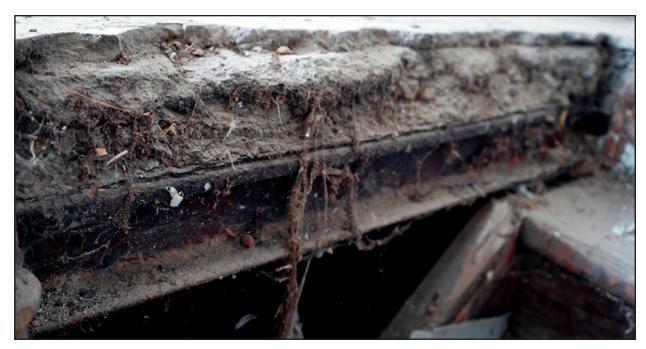
The building is largely structurally sound. However, moisture-related deterioration is evident in several areas, especially in wet zones where plaster spalling and mold formation are prominent. The cement-based plaster on the basement ceiling has lost integrity, and significant swelling is observed on upper-floor ceilings due to longterm water infiltration.

Figure 15. Metal elements of the jack arch flooring and cement plaster

Cement-based plasters, especially those used in previous repairs, will be entirely removed.

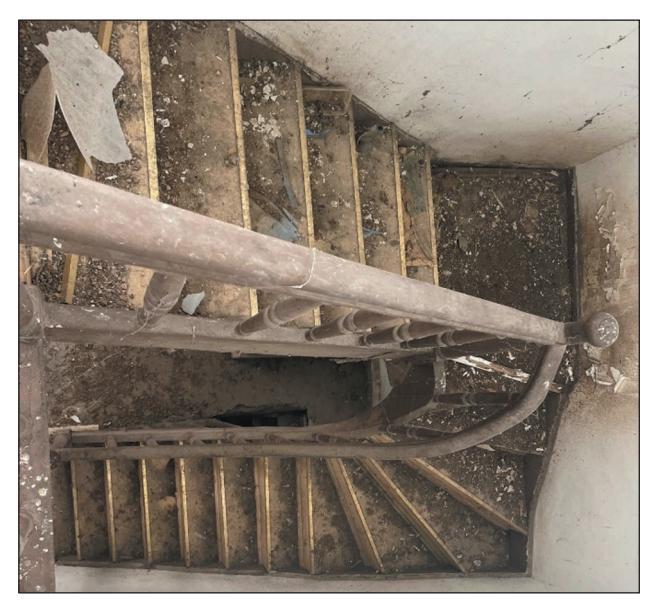
Figure 16. The staircase and upper landing

The existing wooden staircase will be preserved wherever possible. Damaged or decayed steps will be replaced using the same materials and original detailing techniques.

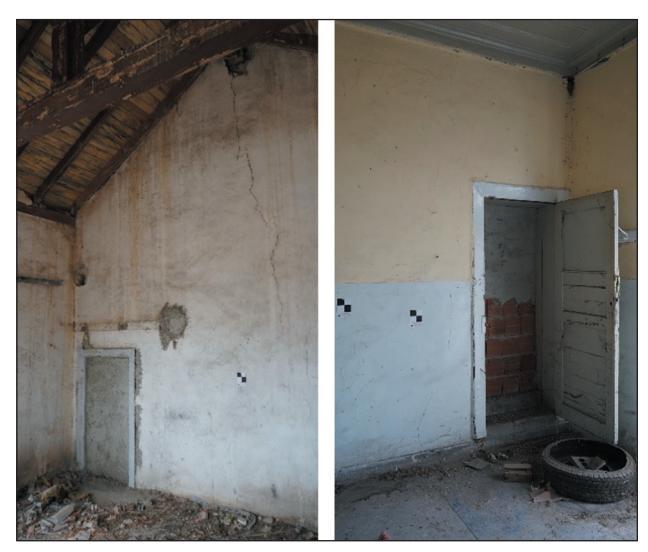
Figure 21. The door connecting Z05 with space Z06 was closed by building a wall.

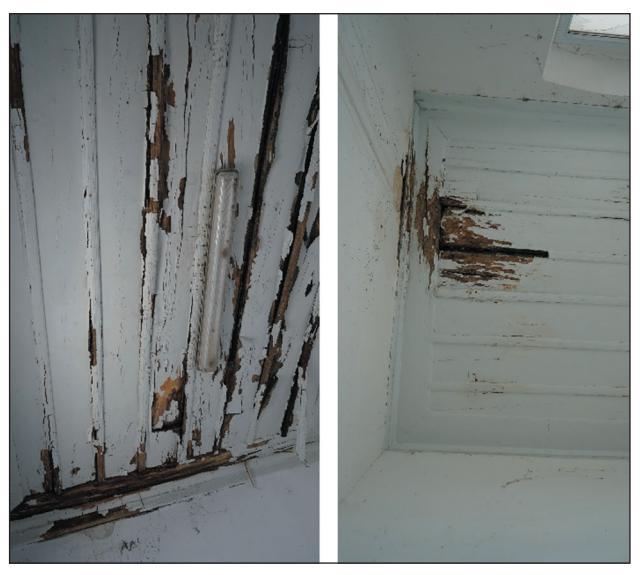
Figure 22. Swelling and material decay caused by water from the roof, especially on the ceilings of the upper floor spaces

Existing lime plasters that have deteriorated due to moisture will be scraped and replaced with new lime-based plaster compatible with the original material. The physical, mechanical, and raw material properties of the original plasters will be determined through laboratory testing to formulate accurate repair mortars.

New plaster applications will be breathable, reversible, and chemically compatible with the historical masonry to avoid salt formation and further degradation.
