# Seismic Vulnerability Assessment of Rural Areas: Case Study of the Vrutok Village and Recane Village in Gostivar, North Macedonia, Using Vulnerability Index Method

Jasemin Hodza Djafer

International Vision University, Faculty of Engineering and Architecture, Gostivar, North Macedonia

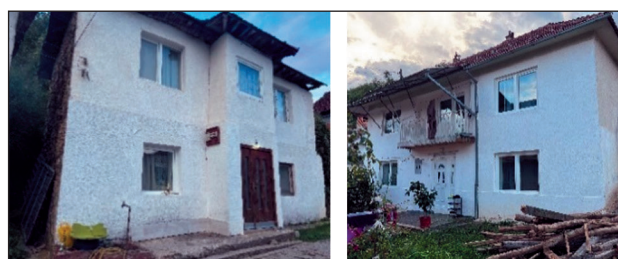
Figure 4.a); b); Existing masonry buildings in Recane village (by author)

In the village of Recane, 23 existing masonry buildings have been identified (figure 4 – a, b), which are intended as single-family houses. %17.3 of the buildings are one-story while %82.7 of the buildings are two-story. %78.2 of the buildings are built of rubble stone or adobe, %21.8 of the buildings is built of simple stone or brick.

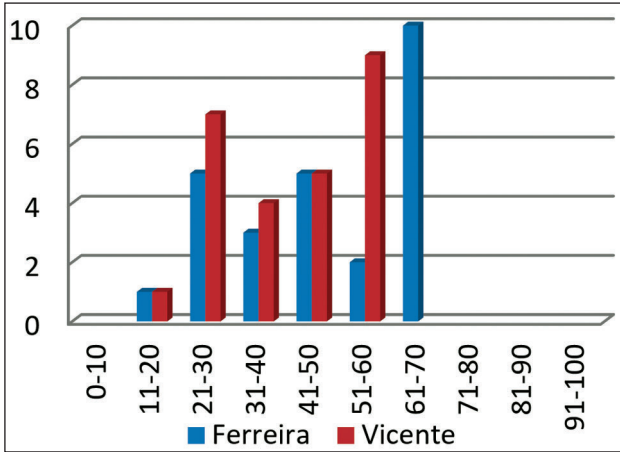
Figure 5. Percentage representation of buildings according  $I_{vf}$ -Vrutok (by author)

the vulnerability index  $I_{vf}^*$ , which is calculated by equation (2). The vulnerability index  $I_{vf}^*$  is normalized from 0 to 100. In the calculation of the vulnerability index the weighting factors provided by Vicente and Ferreira were used. In figure 5 and figure 6 is show percentage representation of buildings according to normalized vulnerability index  $I_{vf}^*$ . Spatial distribution of normalized vulnerability index  $I_{vf}^*$  is shown in figures 7 and 8.

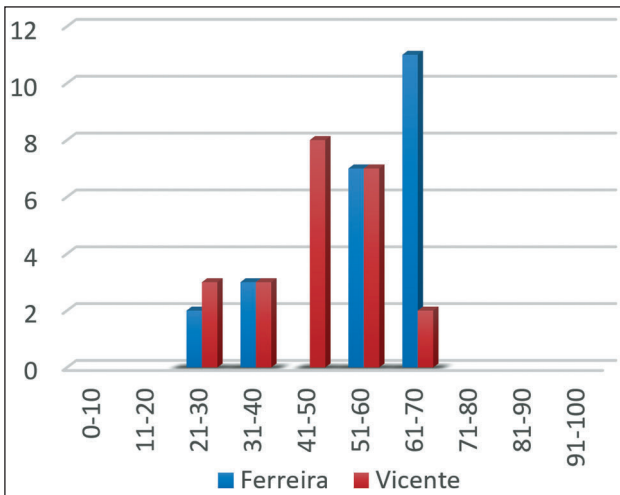
Figure 6. Percentage representation of buildings according to  $I_{vf}$ -Recane (by author)
