Review of the recent restoration of the Vefa Kilise Camii

Mine Esmer

Fatih Sultan Mehmet Vakıf University, Istanbul, Turkey.

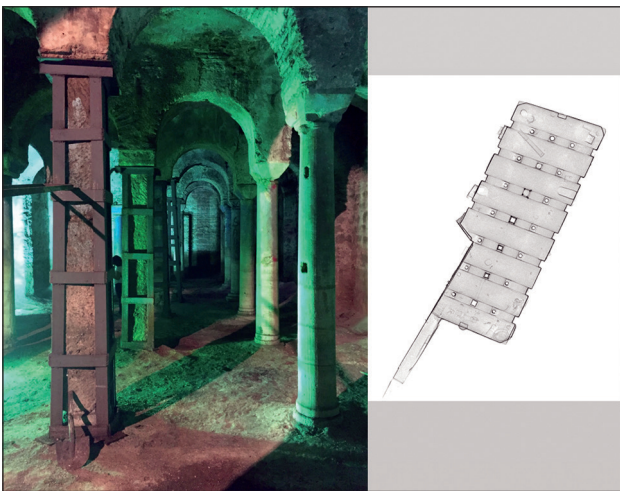
Figure 1. The cistern located 30 meters west of the Kilise Camii (2018). In overview map on the right, it is seen that one of the walls of the cistern is partially cut because of the structure built illegally on it in 1966.

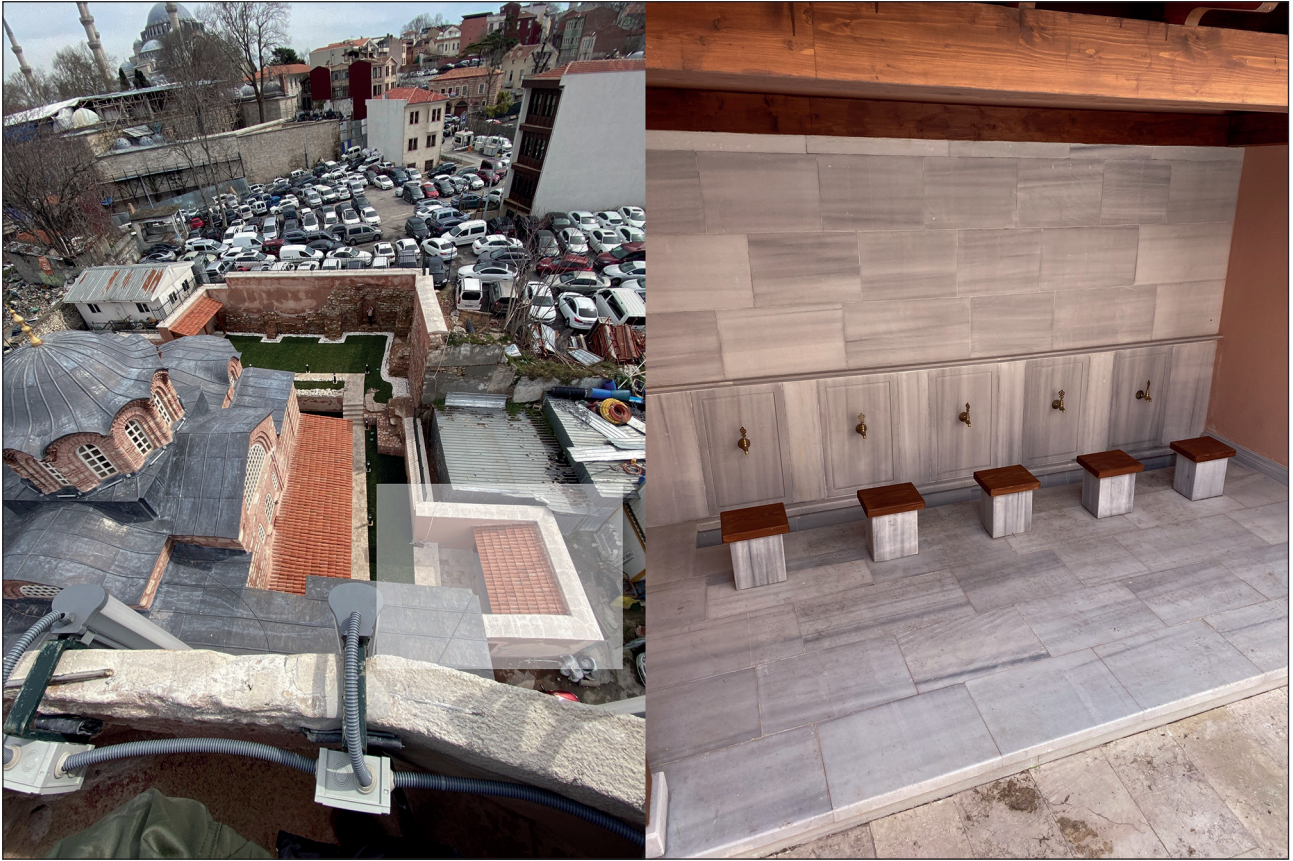
Figure 10. The new ablution faucets (2021)

Following the re-opening in March 2021, the mosque began serving as a religious building, and its general view and state of conservation have improved significantly. They removed the wc unit from the north annex, shanty-unit from the outer narthex, and built ablution faucets outside in the courtyard to replace the shantystructure next to the south annex (Figure 10). Further, they uncovered the remnants of the monastery on the east side of the mosque (the

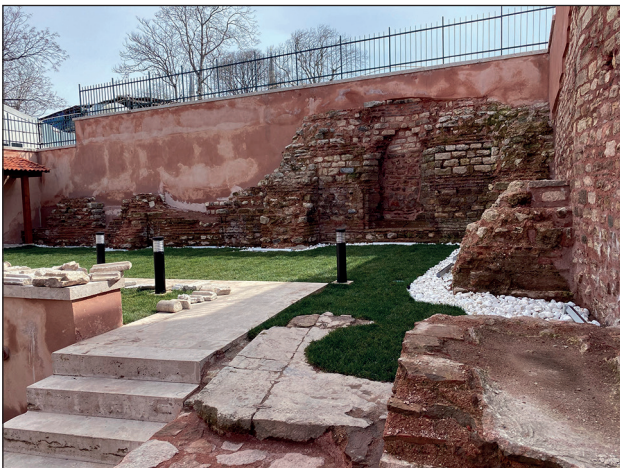
Figure 11. The walls of monastery (2021)

masonry technique is similar, there is also a curvilinear fragment of an apse and a broken cornice on it), and the remains of the wall that formerly housed the mosque's madrasah (Figure 11).

It's deliberately good that they left the remnants without any re-integration. On the south facade, they discovered the bases of the collapsed parecclesion columns. Furthermore, north and south parekklesia, of which Brunov, and Thies
